Contents of the Document

This document is intended for users of the FB Remote I/O system.

This document contains system-relevant information that you require for inserting and removing of active com units of the FB Remote I/O system. The document provides additional information that is not contained in the manual.

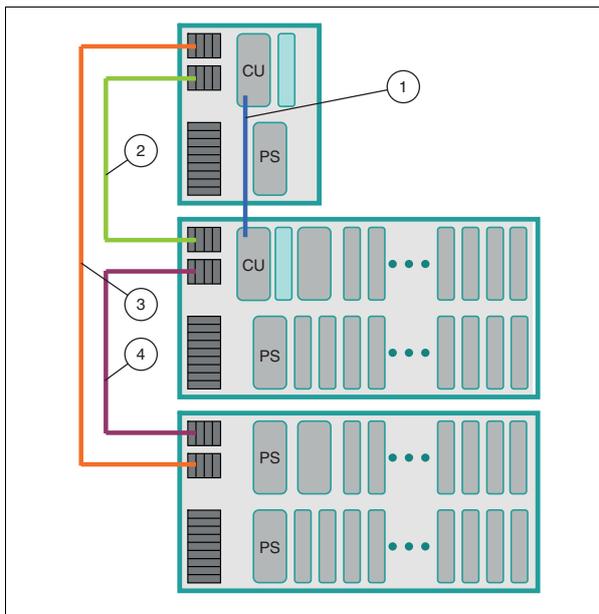
Figure 1 Redundant FB installation with 48 slots

- 1 FB9283 – com unit connection cable
- 2 FB9271 – backplane connection cable
- 3 FB9273 – backplane connection cable
- 4 FB9272 – backplane connection cable
- CU** Com unit
- PS** Power supply

In redundant FB installations, the front connectors of the two com units (CU) are connected to each other via an intrinsically safe com unit connection cable (1). This cable connection (1) is also designated as a front link or redundancy link.

The cable connection (1) is an exclusive com unit/com unit communication connection for the data exchange between the two com units.

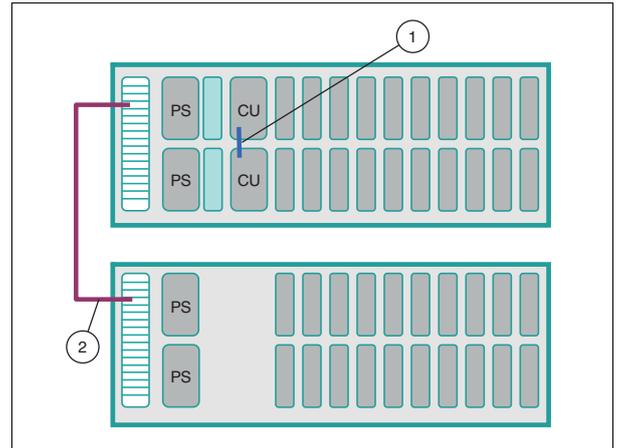
Figure 2 Redundant FB installation with 40 slots

- 1 FB9283 – com unit connection cable
- 2 FB9274 – backplane connection cable
- CU** Com unit
- PS** Power supply
